# LiDAR-Based Landslide Inventory and Susceptibility Mapping, and Differential LiDAR Analysis for the Panther Creek Watershed, Coast Range, Oregon

A thesis submitted in partial fulfillment of the  
requirements for the degree of

Master of Science  
in  
Geology

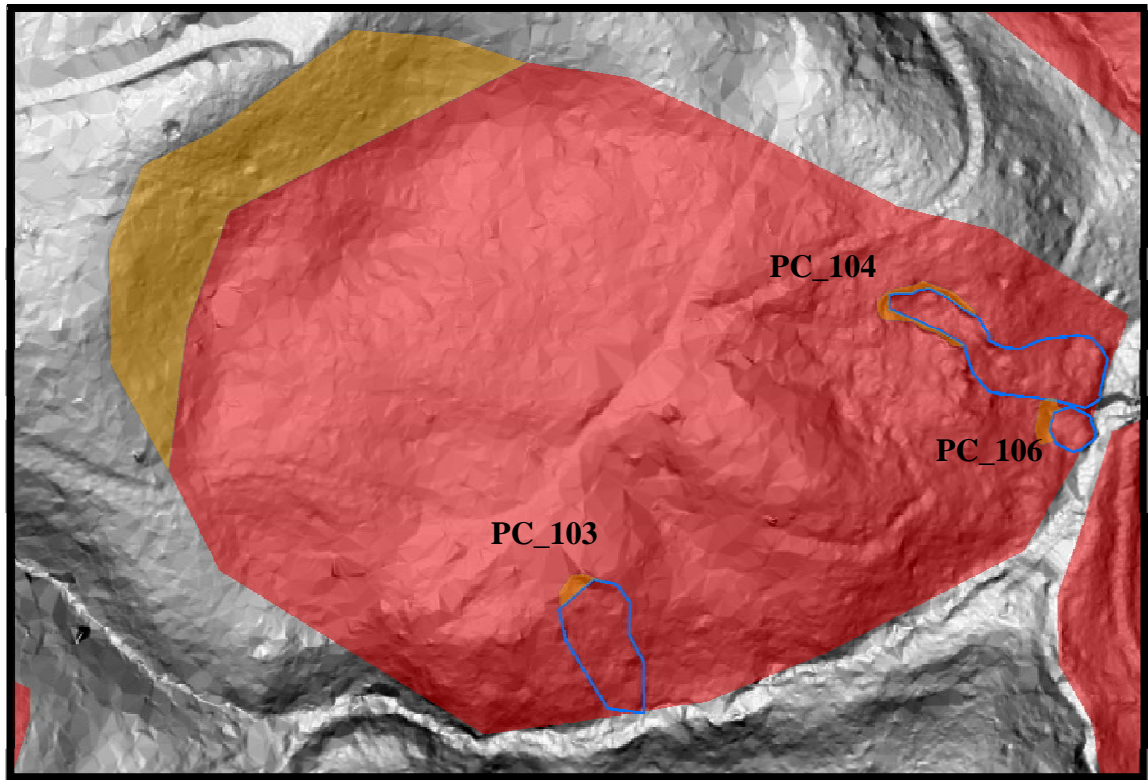
**Figure 25. Three recent landslides (outlined in blue) failing on the toe of a historic landslide deposit PC\_68 (in red).**

Nine of the recently active landslides failed within the boundaries of older landslide deposits. Three failures occurred on older landslide head scarp terrain and three failures occurred on old landslide toes (Figure 25). Of these nine failures, five occurred within historic landslides (<150 years old).

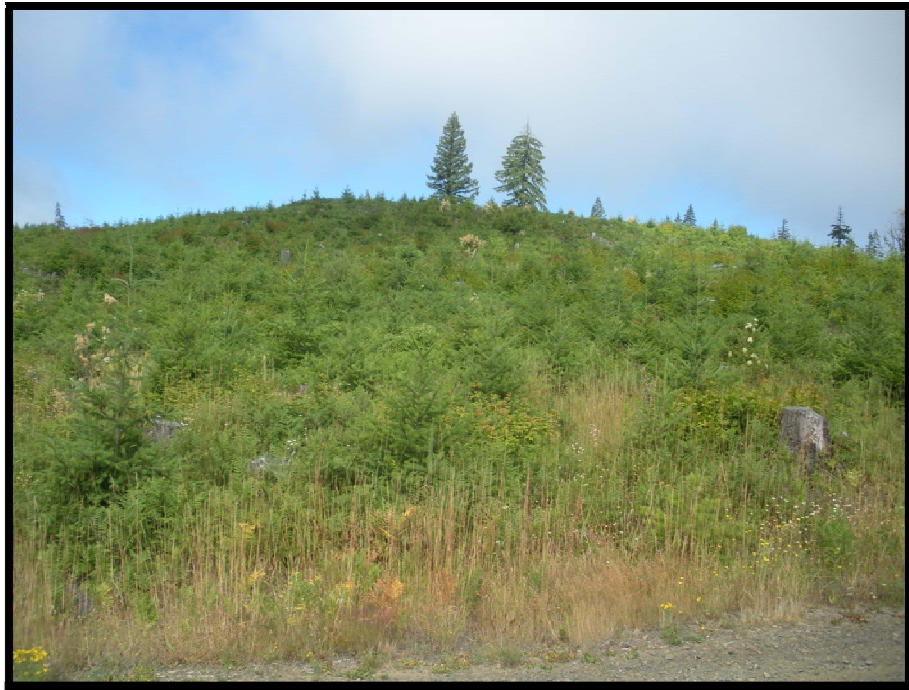
**Figure 26. Short, dense vegetation in recently replanted clearcut areas are common in the study area. This type of vegetation can lead to false identification of active landslides when using differential LiDAR.**

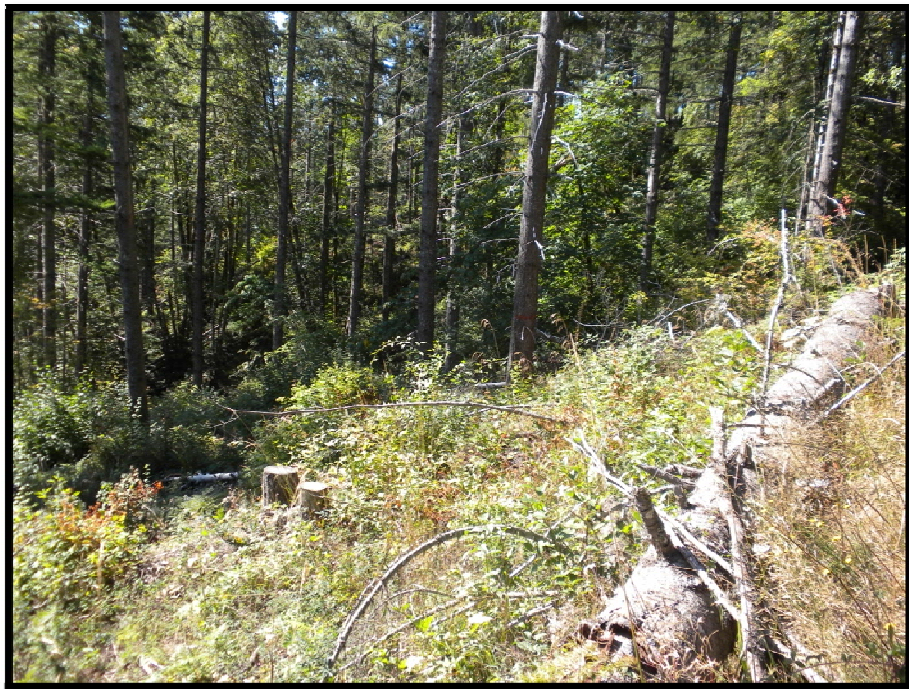
**Figure 27. Misidentified landslide possibly caused by thick, young, deciduous vegetation.**

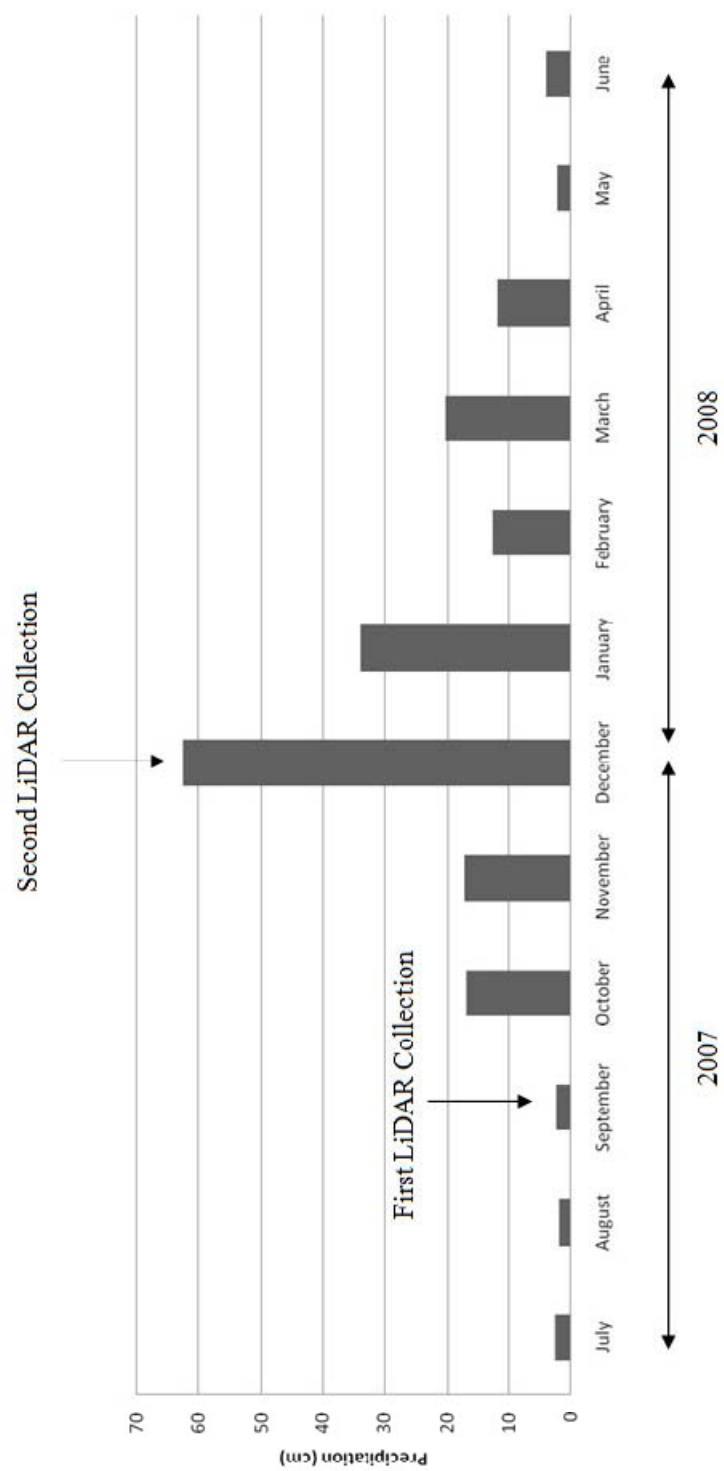
Figure 28. Graph of precipitation between the LiDAR data collection for Differential Dataset 1.

During the three months between the LiDAR collection of Differential Dataset 1 (September – December 2007), 72 cm of rainfall (an average of 24 cm/month) was recorded at the dam at Haskins Creek Reservoir (Figure 2) (Figure 28). However, nearly half of this collective rainfall (34 cm) fell during a storm on December 2-4, 2007 (Burns et al., 2010). During this three month period, 22 landslides occurred in the study area. The large number of landslides may have been due to this large storm event in December.

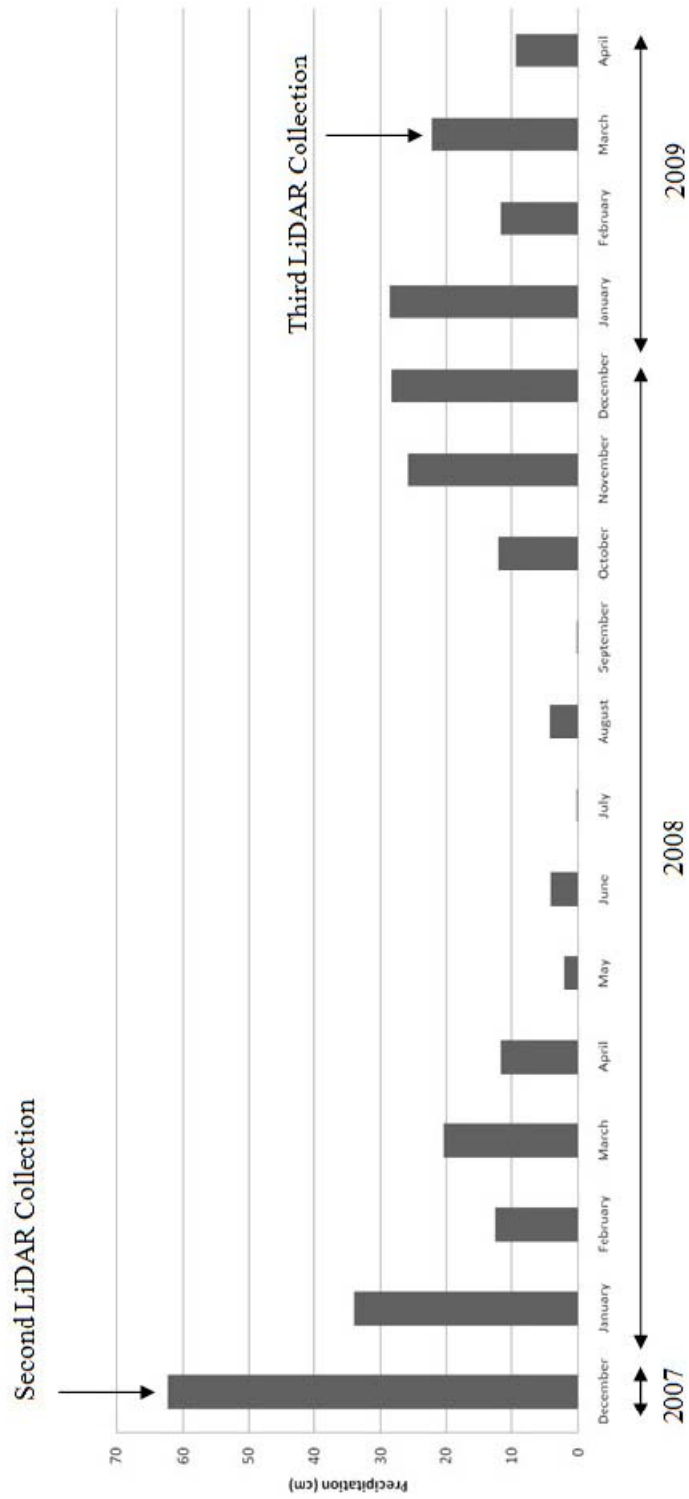
Figure 29. Graph of precipitation between the LiDAR data collection for Differential Dataset 2

During the fifteen months between the LiDAR collection of Differential Dataset 2 (December 2007 – March 2009), 218 cm of rainfall (an average of 14.5 cm/month) was recorded at the dam (Figure 29). Only one significant storm event occurred during this time period on January 1<sup>st</sup>, 2009. In a 24 hour period, 12 cm of rainfall was recorded at the dam. Wiley, 2000, found that there is a linear relationship between rainfall intensity and landsliding in western Oregon. For the study area, 7-10 cm of rainfall in a 24 hour period can trigger landslides and debris flows (Wiley, 2000). The 12 cm of rainfall exceeds these threshold values, indicating the slope failures were possible from this storm event. During this 15 month span, however, only four new landslides occurred and five landslides that moved in Differential Dataset 1 had continued movement. The absence of major storm events during the collection of LiDAR for Differential Dataset 2, may have contributed to the lack of landslide movement.
